CONNECTICUT RIVER BASIN
CLAREMONT, NEW HAMPSHIRE

FITCH RESERVOIR DAM

PHASE I INSPECTION REPORT
NATIONAL DAM INSPECTION PROGRAM

DECEMBER 1979

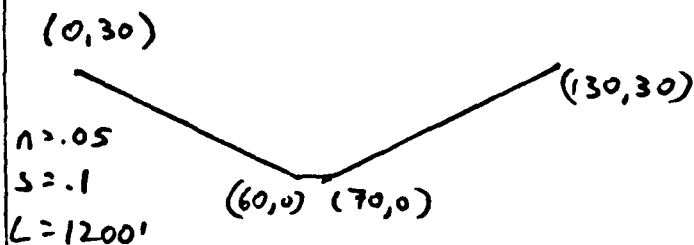
Tailwater is controlled by the stream downstream of the reservoir. The following cross-section is typical for the 1200 ft. reach of Grandy Bk. from Fitch Reservoir to McQuade Reservoir (based on field notes and USGS Topo.):

A Depth-Normal flow relationship for this reach is given on p. 9. The pre-failure outflow of 238 cfs would cause 2 feet of flow.

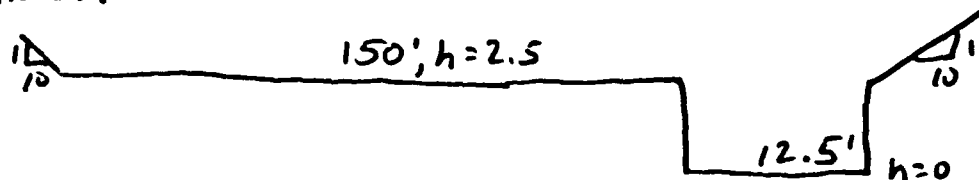
McQuade Reservoir Dam is an earth fill structure. The following elevation of the dam is based on field notes.

A stage-Discharge Curve for this dam is given on p. 12. The ^{surge} storage behind McQuade Reservoir Dam is estimated as 1 (h). The attenuated Peak Dam Failure Outflow over McQuade Reservoir Dam is calculated on p. 14. The attenuated peak dam failure flow of 22,500 cfs would create

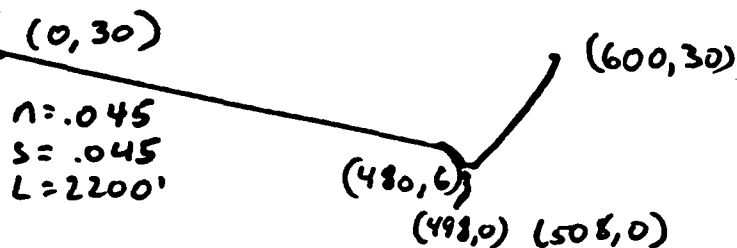
The following cross-section is typical for the reach from McQuade Res. Dam to Road Crossing #1 (based on field

notes and USGS topo):

A Depth-Normal Flow relationship for this reach is given on p. 17. The pre-failure flow of 240 cfs would cause about 2 feet of flow in this reach. The attenuation due to storage in the reach is calculated on p. 18.

The attenuated peak failure outflow of 13,500 cfs would create a stage of 11.2 ft at the downstream end of this reach. The two houses threatened by dam failure are about 25% of the way down this reach. Assuming 25% of the attenuation occurs before these houses are reached:

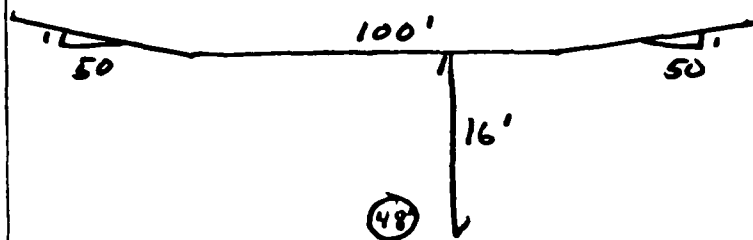
According to the FHA's Hydraulic Engineering circular number 5, the capacity of the culvert is about 250 cfs with the water level at the roadway. The flow over the top of the road could be approximated as:

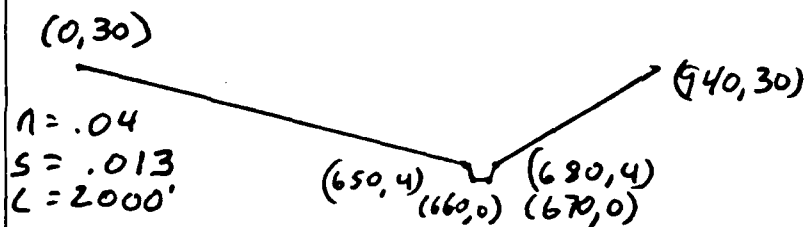
Grandy Brook next runs some 2000 feet through a flatter area with a broad floodplain to a small pond. The following typical cross-section for this reach is based on field notes and U.S.G.S topo information:

A Depth-Normal Flow relationship for this reach is given on p. 24. The pre-failure flow of 240 cfs would cause about 2½ ft of flow. The attenuation due to storage in this reach is calculated on p. 25.

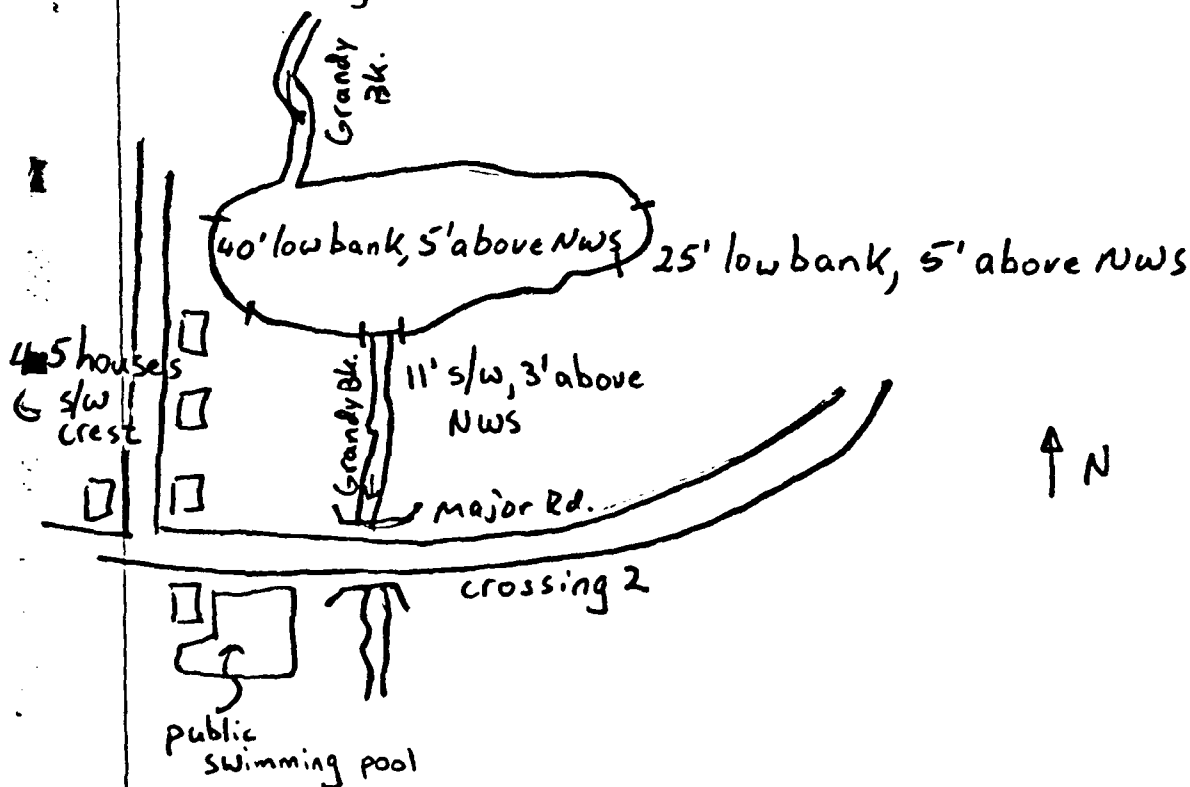
The small pond at the D/s end of this reach has a surface area of less than 1 acre, and thus does not have enough storage to attenuate peak dam failure flows significantly. The sketch below shows this pond and the surrounding area (based on field notes):

A stage/discharge relationship for the small dam is given on p. 21. The 5600 cfs peak dam failure outflow would create a stage about 9 feet above the spillway crest. About 920 cfs would go over the spillway, 2130 cfs over the 40' long low bank to the east, 1330 cfs over the 25 ft. low bank to the west, and 1220 cfs over the dam crest. The embankment of this ~~do~~ small pond is in poor shape, and would be damaged or destroyed by this flow.

The 2130 cfs going over the 40' low bank, + some of the ~~1220~~ 1220 cfs over the dam's top would flow through a group of 4-5 houses to the southwest of the pond at about spillway level. There would be noticeable damage to these houses and some potential for loss of life. The potential for loss of life would be particularly high if the high bank to the east of the spillway were to fail, increasing the flow at the houses suddenly.

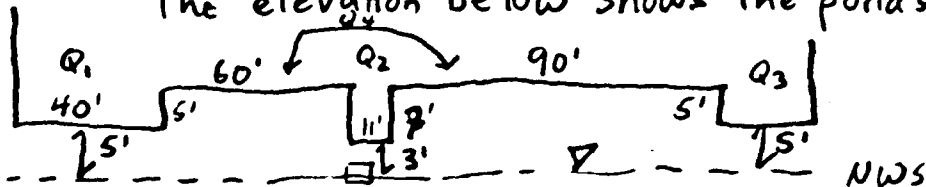
The elevation below shows the pond's hydraulic profile:

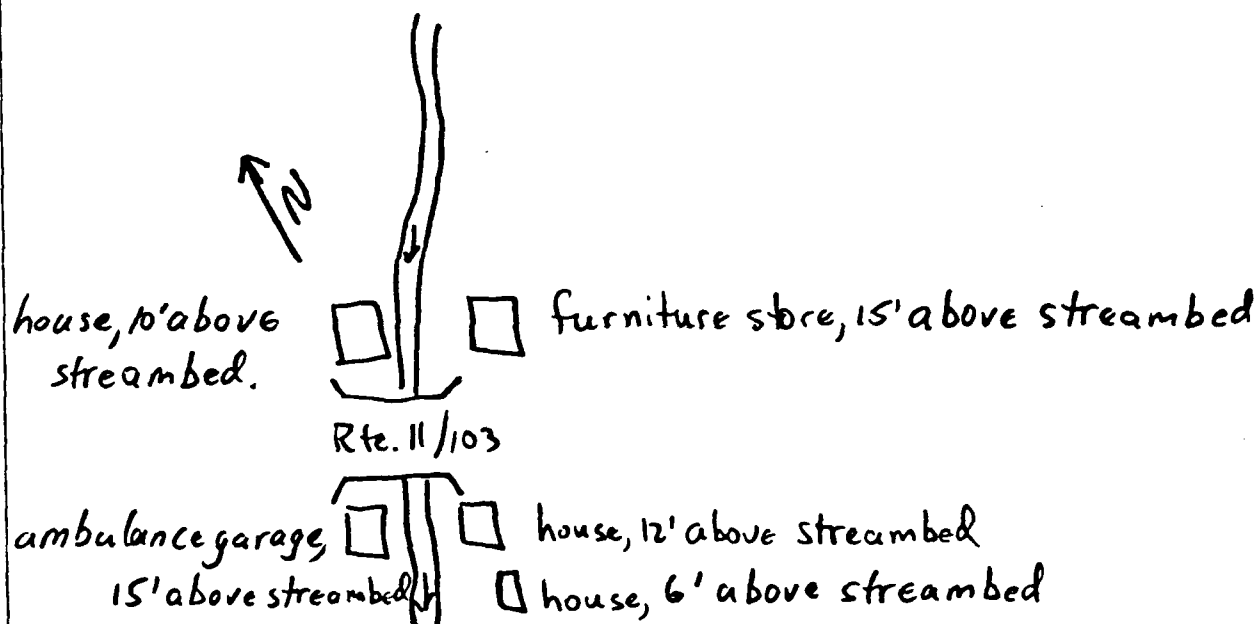
Downstream of this road, Grandy Blk. runs about 2500' to a 3rd major road crossing, N.H. Routes 103 & 11. These reach includes a small reservoir on the brook. The only other development is at the road crossing (based on field notes)

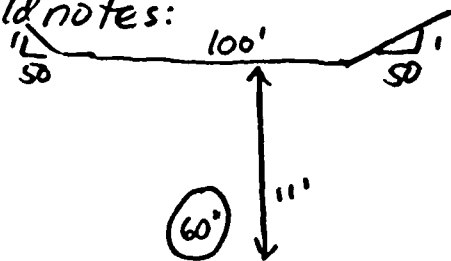
The following elevation of the Rte 103/11 crossing is based on field notes:

According to FHA HEC #5, this culvert would pass about 300 cfs with the water surface at road level. Thus

it seems likely that dam failure flows would be sufficient to overtop, and possibly damage or destroy, this crossing. There is also potential for damage to the houses and stores at the crossing, although the potential for loss of life seems low.
